## Hurricane Test Laboratory, Inc.

### STRUCTURAL TEST REPORT – FIXED WINDOW

Job #: 0226-0403-00

- 5.1 Model Designation: NON-IMPACT GLASS BLOCK SYSTEM IN ALUMINUM FRAME
- 5.1 Overall Size: 65-in. (w) x 65-in. (h)
- 5.2 Configuration: Fixed
- 5.3 No./Size of Vents: N/A

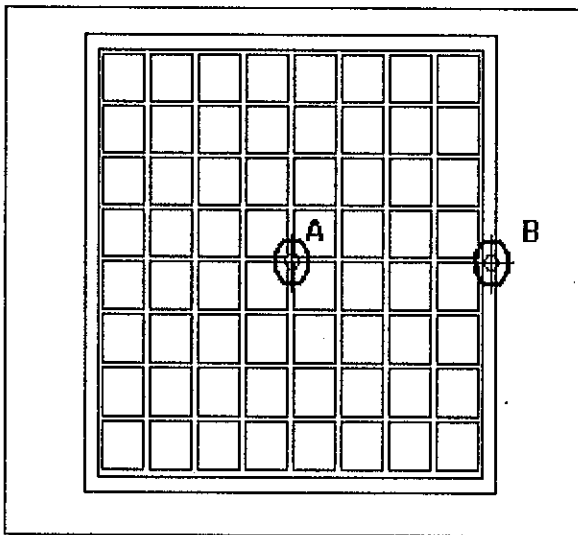
**11.2 LOCATION OF DEFLECTION MEASUREMENTS:**

Deflection was measured at geometric center of the window and the center of the right frame jamb. According to section 2.1.4.1 and 2.1.4.2 of AAMA 101-97, the Uniform Load Structural Test was conducted in accordance to ASTM E330. Each load was applied for 33 seconds (except for the test loads, they were applied for 10 seconds each). No signs of failure were observed during the test. As such, this specimen was found to satisfy the uniform static load test requirements set forth by AAMA101-97 and ASTM E330. This test was completed on 4/5/00.
