STRUCTURAL PERFORMANCE TEST REPORT

REPORT NO.: NCTL-210-1860-4
TEST DATE: 08-20-96
REPORT DATE: 09-03-96

TEST SPECIMEN: Florida Extruders International Inc.'s Series "Milestone 1000" Horizontal Sliding Aluminum Prime Window. (Type XO) (HS-R50) (Design Pressure 50 psf Exterior & Interior)

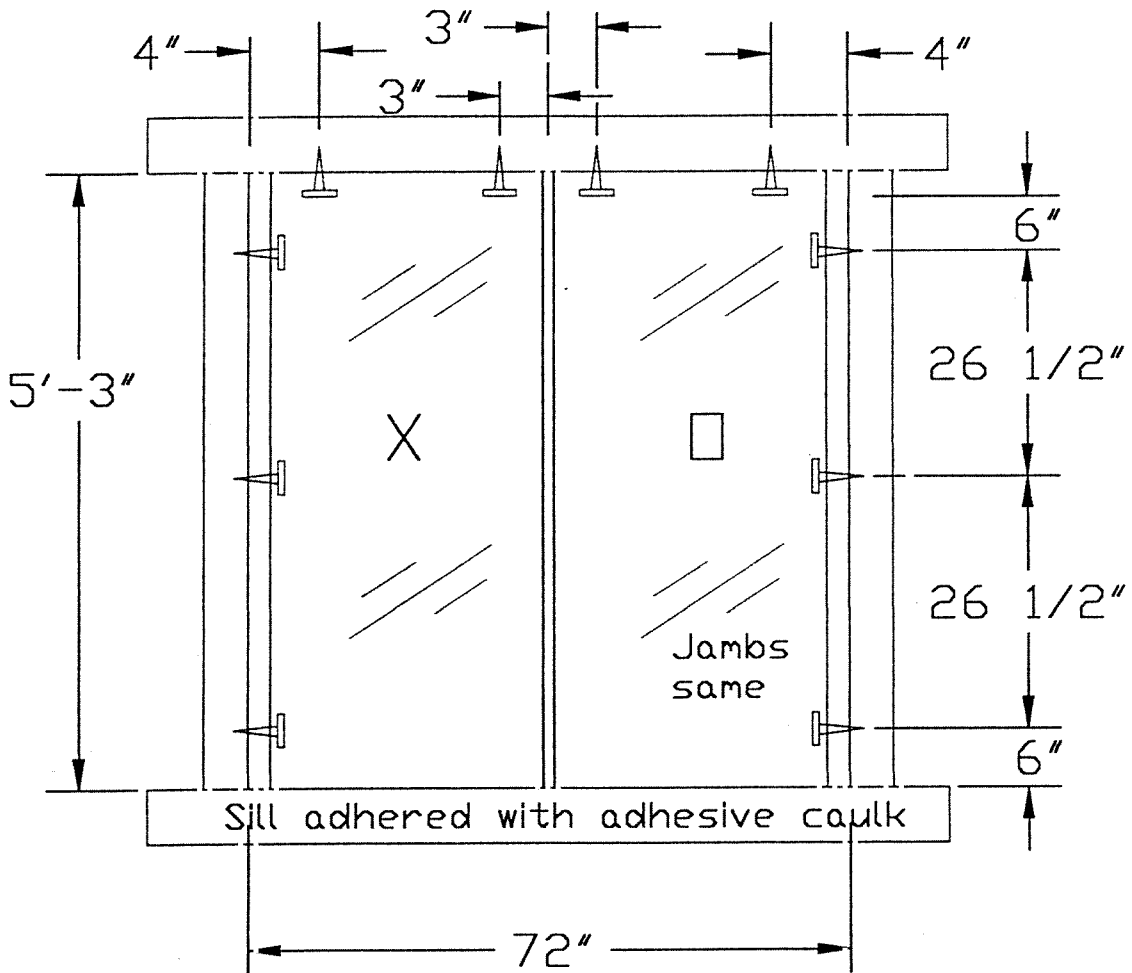
FASTENER LOCATIONS

The test specimen was flange mounted to the test buck using ten (10) #8 X 1" screws at locations shown.

△ - DENOTES SCREW

INSTALLATION: The frame was mounted into the wood test buck using ten (10) (# 8 x 1") flat head screws.
